Rehabilitating and Restoring Unique Landscapes

June Newsletter

The Maritime Aboriginal Peoples Council's Five Watersheds Project will address areas of fish habitat concern in the **Chiganois, Debert, Folly, Great Village, and Portapique** Watersheds. Four of the five watersheds within the project scope are identified as critical habitat for the endangered inner Bay of Fundy (iBoF) Atlantic Salmon.

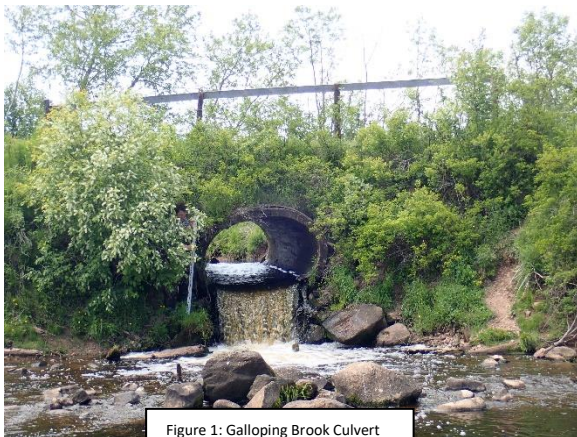
Figure 1: Galloping Brook Culvert

During initial survey work, a wooden culvert was discovered to be a height barrier preventing fish from passing the vertical height from pool to culvert. In the early summer of 2018, field technicians caught nearly 1000 Gaspereau in a pool with a beach seine just downstream of the culvert. Upstream through the culvert, there is optimal spawning habitat for Gaspereau in MacElmons Pond. This barrier to fish passage made it evident that this culvert would need restoration or replacement.

Although this theory has not been confirmed, it is suspected that this culvert was installed before the aboiteau that was constructed on the Chiganois River in 1955. Since the construction and joining of small aboiteaux along the Chiganois river, the water levels have dropped, making this culvert crossing a barrier for fish passage.

Working with the NSLC Adopt-A-Stream program, and with the support of the MAPC Five Watersheds Advisory Board, the denil structure option was selected as a cost effective alternative to a complete culvert replacement which would be

a very costly option. A Denil Structure would be designed for the Galloping Brook location. A denil structure is designed and installed separately from an existing culvert. The structure has its own entrance and outlet, and is placed at an engineered location beside the fish barrier culvert.

The intent of structure is to reduce the velocity of the water flow by placing a series of baffles along the floor of the denil while accommodating a gradual upward slope for fish to swim through to the other side where the fish can continue on to their optimum spawning habitat. With a denil installed, fish are not stopped by an impassable culvert, nor are they forced to move through excessively fast rushing water.

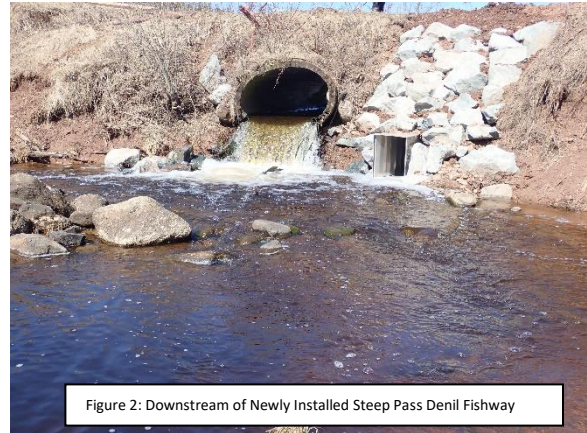
Figure 2: Downstream of Newly Installed Steep Pass Denil Fishway

Below is an image of the completed denil structure at Galloping Brook. Migratory fish are able to travel upstream and reach spawning grounds and reach other food sources.

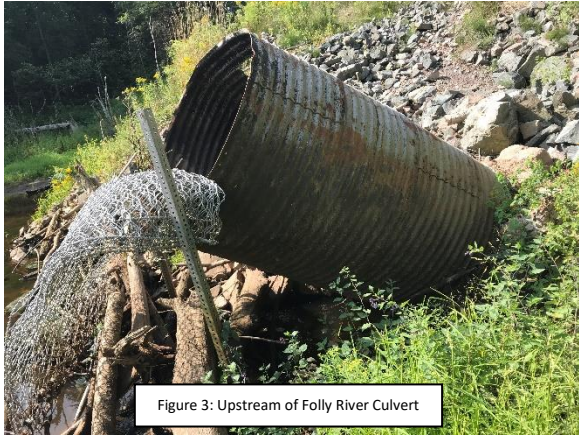
The second location that was added to the restoration plan, is an undersized culvert located on a tributary of the Folly River. The Folly River is considered critical habitat for the inner Bay of Fundy Atlantic Salmon. This culvert is made from corrugated steel pipe, and is approximately 32 meters in length.

When initially surveyed in the spring of 2018, it was evident that this culvert was extremely damaged.

Due to the height of the culvert from the water, and the depth of the water flowing through it and where the culvert is situated under approximately 10 feet of gravel from the road above, it was suggested that ice formation in a pond located upstream of the culvert, caused the metal to crack and bend upright (Figure 3). The wooden debris has been cleared since this photograph was taken.

decided that there is an urgent need to have a temporary fix of the culvert. A fix is planned for the summer of 2019. Although no concrete plans have been prepared, a chute was suggested as a temporary fix. A chute would be attached to the culvert on the downstream end. This chute system will raise the water level in the culvert, making it possible for fish to pass through to the other side.

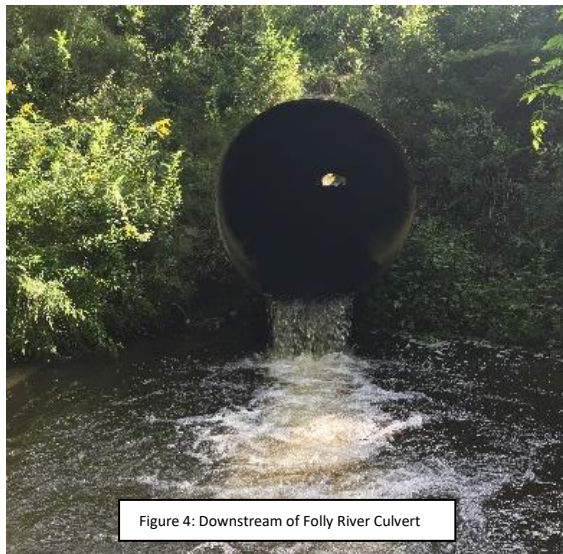
On the downstream end, there is a vertical barrier making it nearly impossible for fish to travel through (Figure 4). Also, because of the water depth, the length of the culvert, and the limited burst speed of the fish, traveling through this culvert is very likely an impossible feat for fish.
