Rehabilitating and Restoring Unique Landscapes

December 2021 Newsletter

The Maritime Aboriginal Peoples Council's Five Watersheds Project will address areas of fish habitat concern in the **Chiganois, Debert, Folly, Great Village, and Portapique** Watersheds. Four of the five watersheds within the project scope are identified as critical habitat for the endangered inner Bay of Fundy (iBoF) Atlantic Salmon.

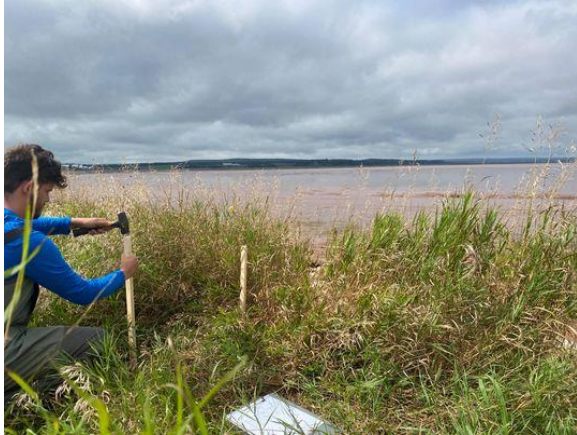
To monitor coastline erosion, the Five Watersheds staff used the Stake Siting method at the mouth of every river. Over time, staff are able to measure the amount of coastline lost to erosion from the profiles they create. A profile is created by placing a series of two wooden survey stakes (in some cases, a permanent structure can be used) into the ground adjacent to the coastline. One stake is installed a certain distance back from the edge, and the other is installed a distance away from the first stake, in line with a particular compass bearing. The team measures the distance between the stakes, and the distance of the stakes to the

coastline. The stakes will be checked every few months to estimate the amount of coastline being lost to erosion.

Figure 2: Field Technician Installing a profile at the mouth of the Chiganois River.

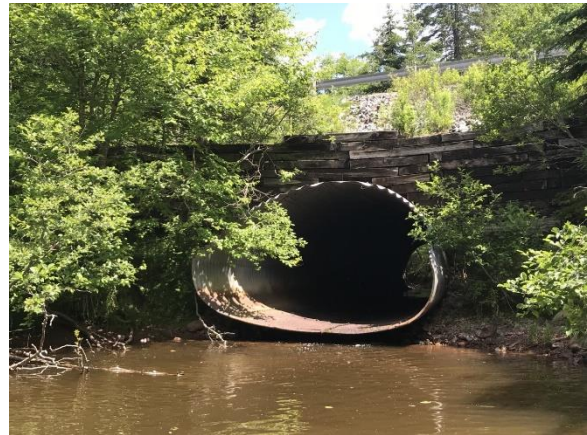
In 2019, the Five Watersheds staff identified a severely damaged culvert on a tributary to the Debert River, named Pine Brook, which is identified as critical habitat to endangered inner Bay of Fundy Atlantic salmon. The culvert had deterioration along the bottom which caused the water to begin to flow under the culvert. It was also a hung culvert, meaning that there was a vertical barrier for fish from the water to the culvert (see figure 3). The Five Watersheds team contacted the owner of the culvert, the Department of Transportation and Infrastructure Renewal (TIR) to see if they were aware of the issues associated with the culvert. Unfortunately, they were not aware of the condition of the culvert, and didn't have any plans to repair the damage. However,

because an endangered species (salmon) are present in the river system, they must have the ability to pass through the culvert to spawn and access prime habitat.

Figure 3: Outflow Before Restoration Activities at Pine Brook

To remediate the culvert, TIR consulted their engineer, and river restoration expert to develop a plan to re-establish fish passage and repair the damaged culvert bottom.

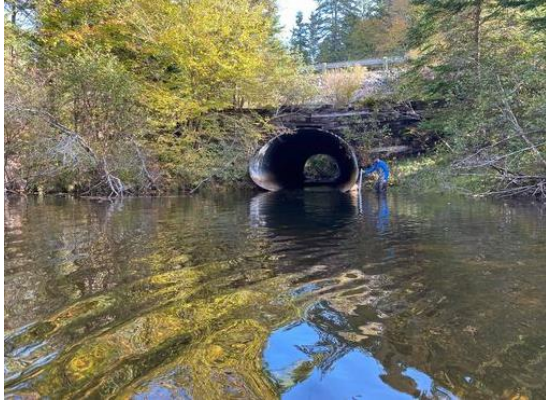
Figure 4: Outflow After Restoration Activities

First, TIR diverted the water with large pumps through the culvert so they were able to use an all-natural spray foam to fill the under, and alongside of the culvert. With the bottom of the culvert sealed with foam, the water was able to flow through the culvert properly.

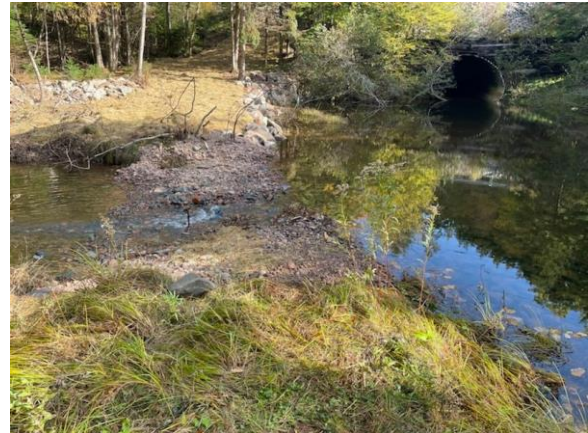
Figure 5: 1st Rock Weir installed at tailwater control to raise water level to inside the culvert

Although the water was flowing through the culvert, TIR's engineer and the restoration expert still needed to raise the tailwater control to backwater the culvert to allow for fish passage. To raise the water level to backwater the culvert (or raise the tailwater control), TIR and the restoration expert designed a series of rock weirs to build up the river gradually. Using an excavator, smaller rocks were brought down to the stream side where 2 rock weirs were created (Figure 5/6). These gradually raised the level of the river and the water level of the pool to backwater the culvert.

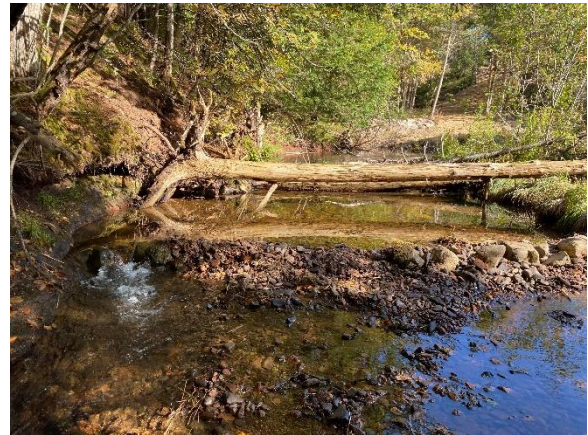
Figure 6: 2nd Rock Weir installed at the crest of the riffle downstream of culvert
