# Rehabilitating and Restoring Unique Landscapes

## October 2019 Newsletter

The Maritime Aboriginal Peoples Council's Five Watersheds Project will address areas of fish habitat concern in the **Chiganois, Debert, Folly, Great Village, and Portapique** Watersheds. Four of the five watersheds within the project scope are identified as critical habitat for the endangered inner Bay of Fundy (iBoF) Atlantic Salmon.

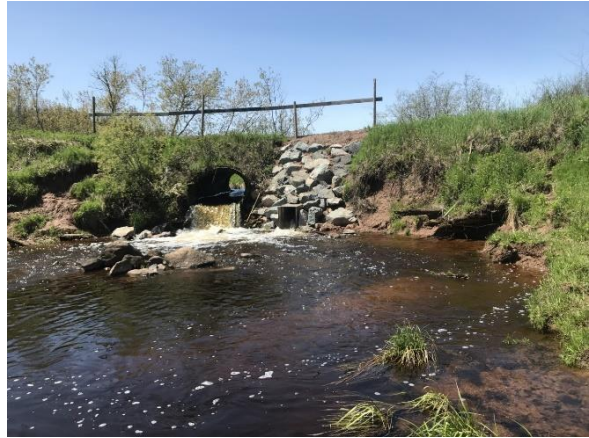
Figure 1: Downstream of Newly Installed Denil

The Five Watersheds Project applied for and received additional funding for a Steep Pass Denil structure. This structure slows the water velocity down inside, and also creates small pools for the fish to rest while they travel through. The Denil was installed during the first week of April, 2019. The field technician and project manager monitored the denil twice a week until the arrival of the Gaspereau.

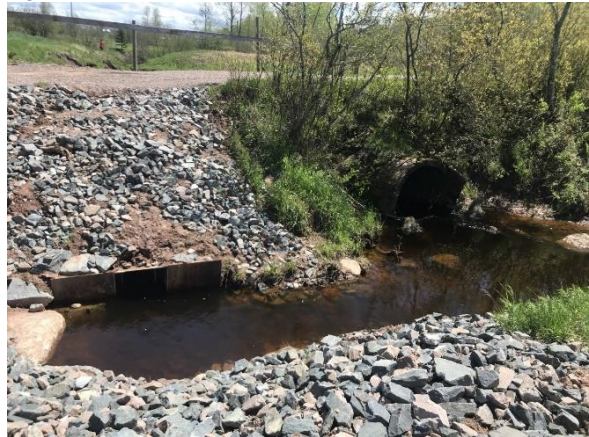
Figure 2: Upstream of Newly Installed Denil

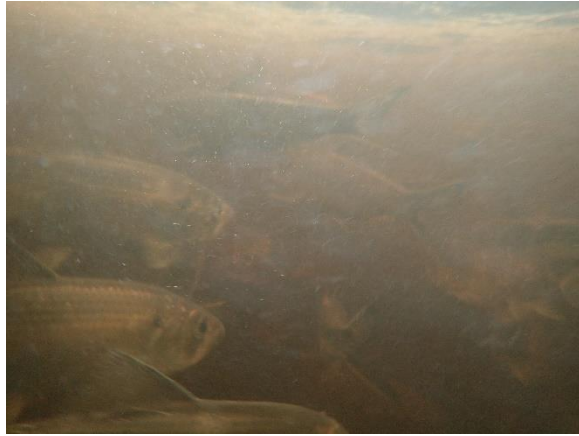
On May 27 2019, the project manager and field technician witnessed what they have been waiting for, FISH PASSAGE THROUGH THE DENIL! Hundreds of fish were traveling through the denil to an optimum spawning ground in MacElmons Pond. This was a significant accomplishment for the project team and the project!

Figure 3: Gaspereau Upstream of Denil Structure

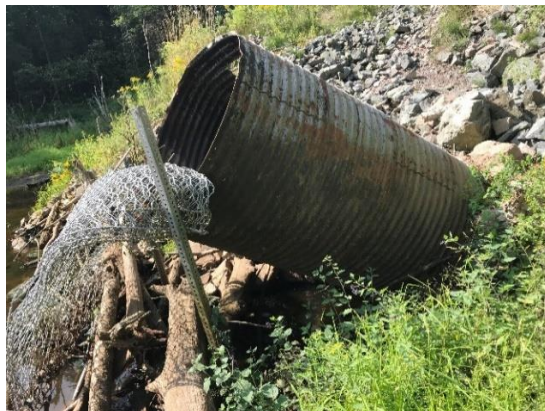
When initially surveyed in the spring of 2018, it was evident that this culvert was severely damaged.

It was suggested that ice formation in the pond located upstream of the culvert caused the metal to crack and bend upright (Figure 4).

Figure 4: Upstream end of Folly River Culvert

After explaining concerns to the Department of Transportation and Infrastructure Renewal, it was decided that there is an urgent need to have a temporary fix of the culvert until this culvert could be added to the capital plan for replacing damaged culverts. The Department of transportation contracted Bob Rutherford, and his consulting firm (Thaumas Environmental Consultants) to prepare and design a solution for the downstream end of this location. The Department of Transportation removed the damaged end of the culvert with an excavator upstream, and stabilized the bank with armour rock. This would reduce debris build

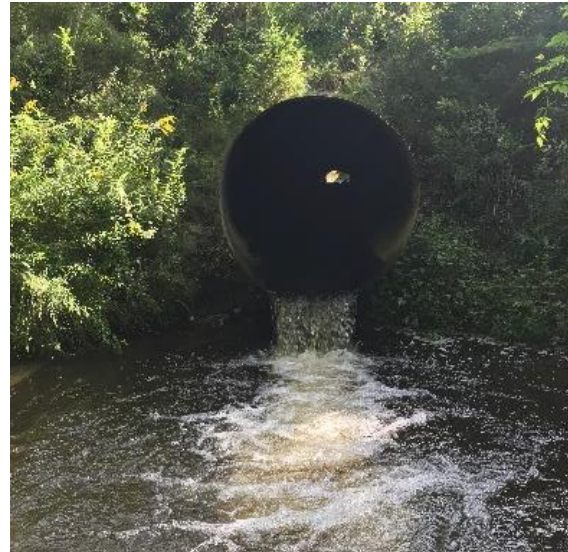
On the downstream end, there is a vertical barrier making it nearly impossible for fish to travel through (Figure 5). Also, because of the water depth, the length of the culvert, and the limited burst speed of the fish, traveling through this culvert is very likely impossible for fish.

Figure 5: Downstream of the Folly River culvert

Further survey work and measurements were taken of the culvert and surrounding area to develop an intermediate plan. Often times, a small chute is attached to the culvert which allows the fish to get up into the culvert. Unfortunately, in this case, the culvert was too high for a chute attachment, and an alternative option was required. An aluminum attachment was fastened to the culvert, and the denil was fastened to the attachment, while it rested on a rock gabion. The attachment helps to backwater the culvert, and the denil allows the fish to travel into the culvert (Figure 6).

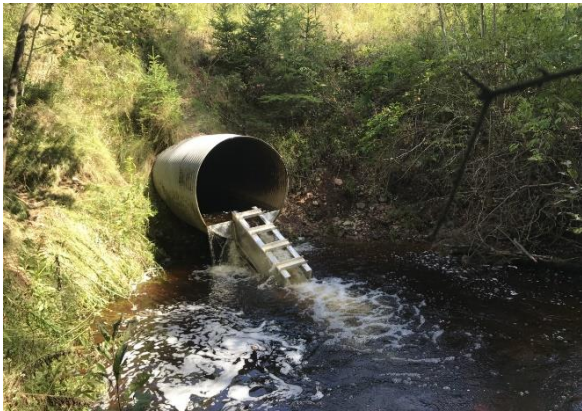
Figure 6: Downstream of the newly installed chute system

During the installation, small Brook trout were trying to migrate through the newly installed denil. Fish passage will also be monitored through this culvert continuously during the remaining term of the Five Watersheds Project.

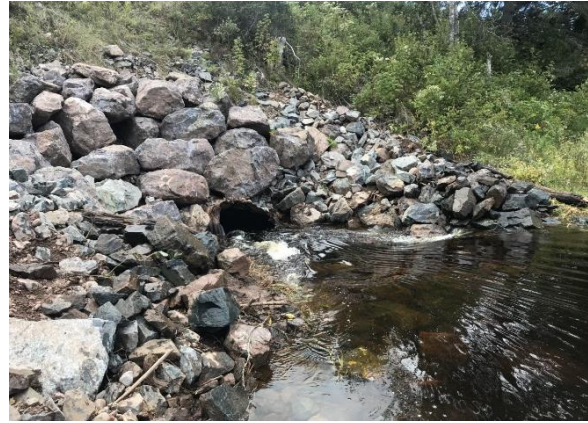
Figure 7: Upstream of the Folly River Culvert

up and provide a more “fish friendly” entrance (Figure 7).

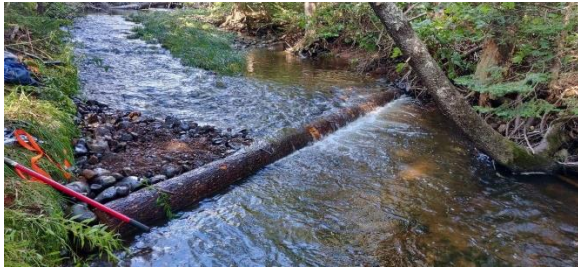
After completing habitat assessments during the summer of 2018, the data and images taken were compiled and sent to Adopt-A-Stream to be analyzed. Based on the compilation report that was provided, the project manager selected three locations that would benefit most from instream restoration work. The location that was chosen is a tributary off the Portapique River called Cook Brook. This brook has great canopy cover, substrate for spawning, and food availability, but lacked pools.

Figure 8: Downstream of Digger log Installed on Cook Brook, Portapique, NS

Digger logs are regularly used instream to increase the quantity and quality of pools in the river for trout, and salmon. The size and location of the logs were determined by Adopt-

A-Stream, as they have to be placed in the natural riffle run sequence of the river. Digger logs have many advantages, they create pool habitat, remove sand and silt from the substrate, and pools capture leaf litter which supports a larger insect population for food, provides better spawning grounds, and cover and over wintering grounds.

The project manager with the project lead field technician installed 8 digger logs this field season. Although installing the digger log is a very labour intensive task, it is very rewarding to see how quickly the digger log begins working in stream!
